**U.S. CONN LIBRARY
RENOVATION PROJECT
PROGRAM STATEMENT**

May 30, 2012

JACKSON-JACKSON & ASSOCIATES, INC

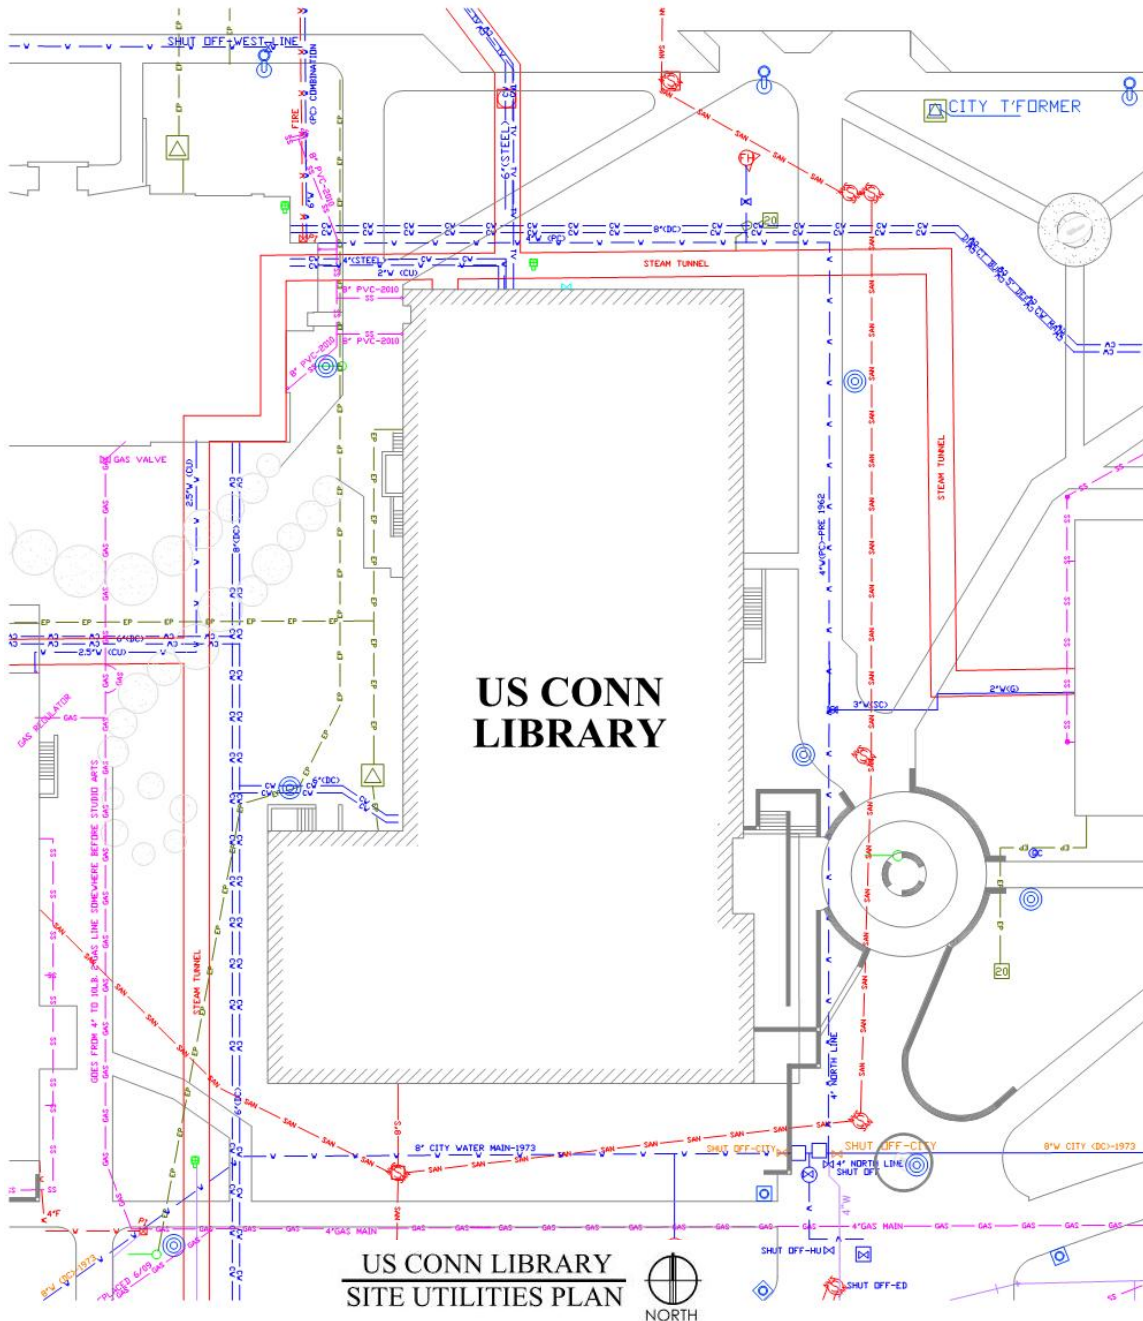
The existing Conn Library building is completely surrounded by underground utilities, as shown on the Site Utility Plan below. Refer to Site Utility Plan on this page. Utilities supplied to the U.S. Conn Library include sanitary sewer, domestic water, central plant high pressure steam, condensate return, central plant chilled water, electrical power and telecommunications. The existing site utilities will be used to serve the needs of the library building during and after the renovation.

The Library building is the central hub for the entire campus' network fiber distribution system from one room on the north end of the existing Lower Level. The fiber network cabling feeds the campus via the campus tunnel system. Existing conditions constitute a single failure point that could bring down the entire campus network. As part of the library programming it would be prudent to consider options for providing improved fault tolerance and diverse fiber pathways for core network functions. These changes would also integrate into the fiber plant analysis included in the Campus Master plan, with the eventual goal of eliminating all single points of failure in the campus data distribution system.

As part of the Campus Master Plan, the existing 4 inch water lines on the east and north sides of the library building are both scheduled to be replaced. The new building domestic water service and fire protection system water service line will come off the existing 8 inch water main on the south side of the library building.

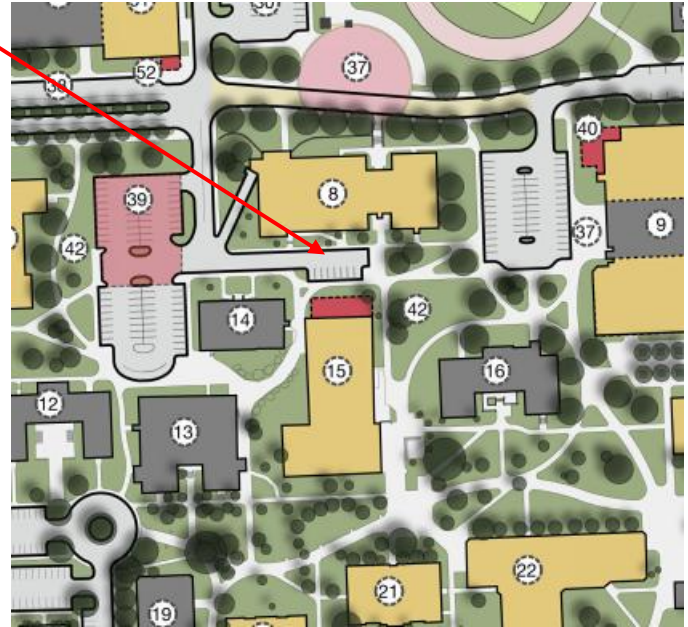
US CONN LIBRARY
PARTIAL MASTER PLAN

To address pedestrian, parking and delivery needs, a second entry on the north side of the building has been included in the program.

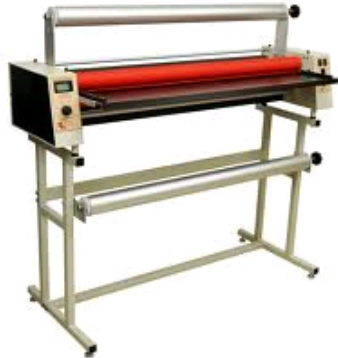
Lamination Space

42" Laminator (shown on left)	5' x 2.25'
27" Laminator	3' x 2'
25" Laminator	2.75' x 1.5'
18" Laminator	2' x 1.5'
Pocket Laminator	2' x 1.5'

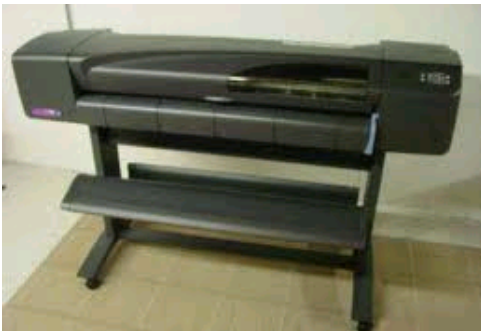
Production Printing

HP 800 designjet Plotter (shown on left)	5.15' x 3'
24" Printer HP 120nr	4'
7500 Laser Printer	3'
Color printer computer table	4'
Shelf (paper)	3'
Work space for color printing	9'
Large Paper Trimmer	6'

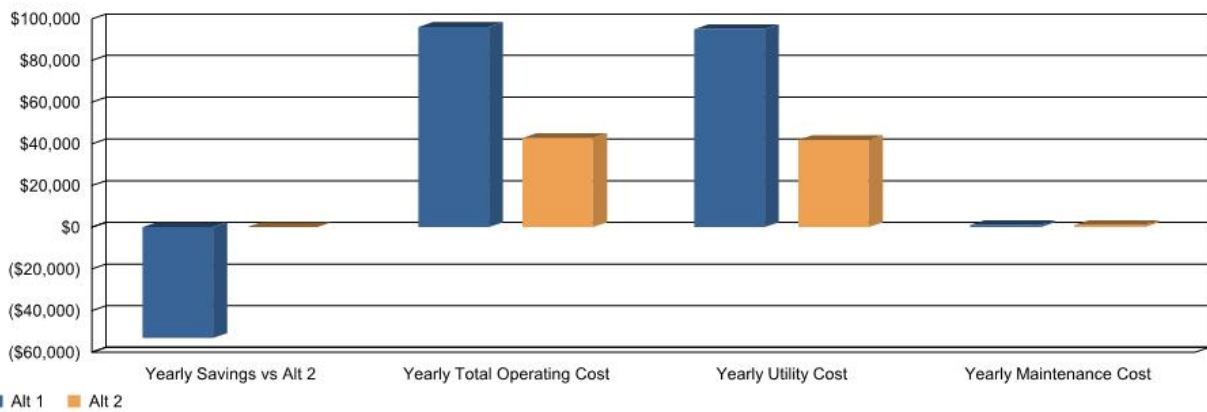
Annual Operating Costs

Yearly Savings vs Alt 2	Yearly Total Operating Cost (\$)	Yearly Utility Cost (\$)	Yearly Maintenance Cost (\$)	Plant kWh/ton-hr
Alt 1	-53,146	96,017	95,017	1,000	0.000
Alt 2	0	42,872	41,872	1,000	0.000

The existing mechanical system will be replaced and upgraded for a **58% Energy Savings**. Refer to the Economic Summary Chart at the end of this section.

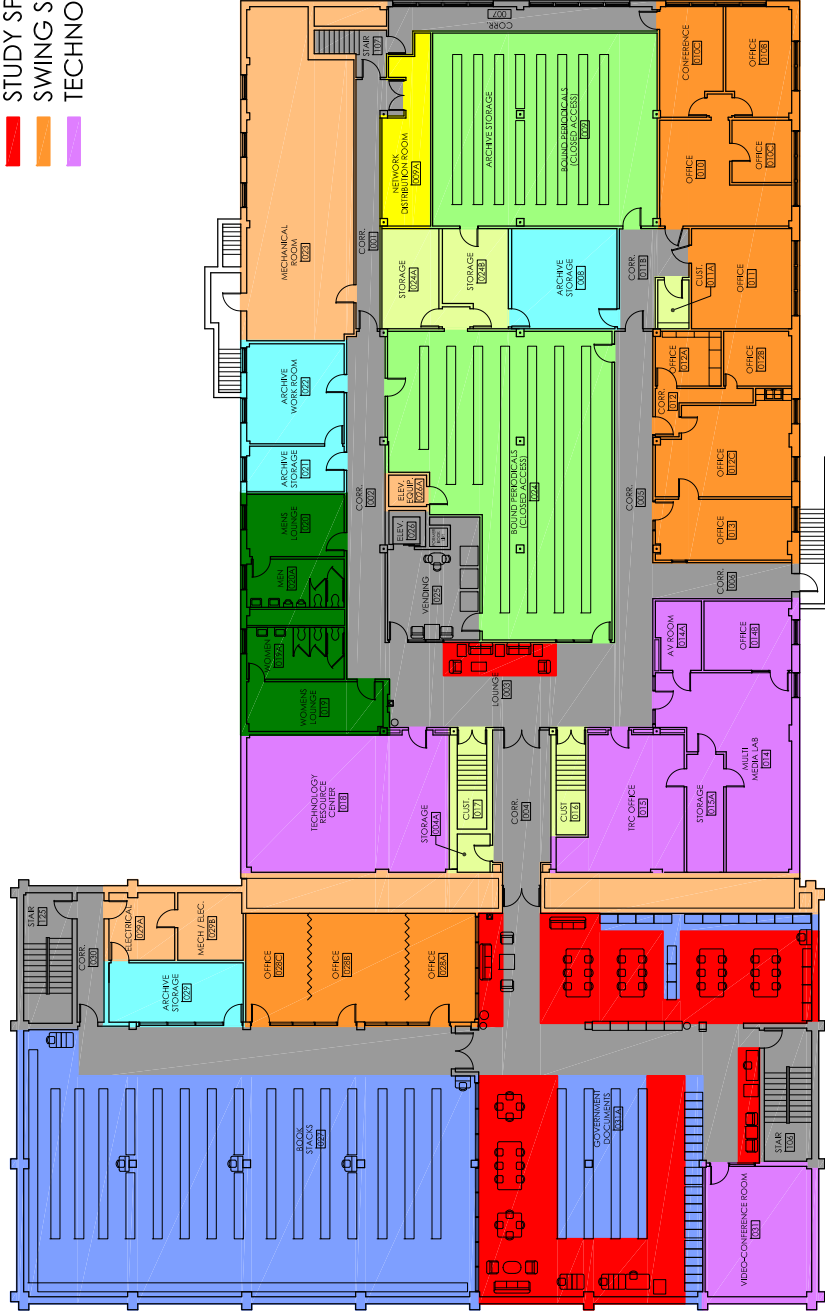
EXISTING LOWER LEVEL FLOOR PLAN 1

- ARCHIVES
- BOUND PERIODICALS
- CIRCULATION
- GENERAL STORAGE
- IT ROOM
- LIBRARY COLLECTIONS
- MECHANICAL / ELECTRICAL
- RESTROOMS
- STUDY SPACE
- SWING SPACE
- TECHNOLOGY RESOURCE CENTER

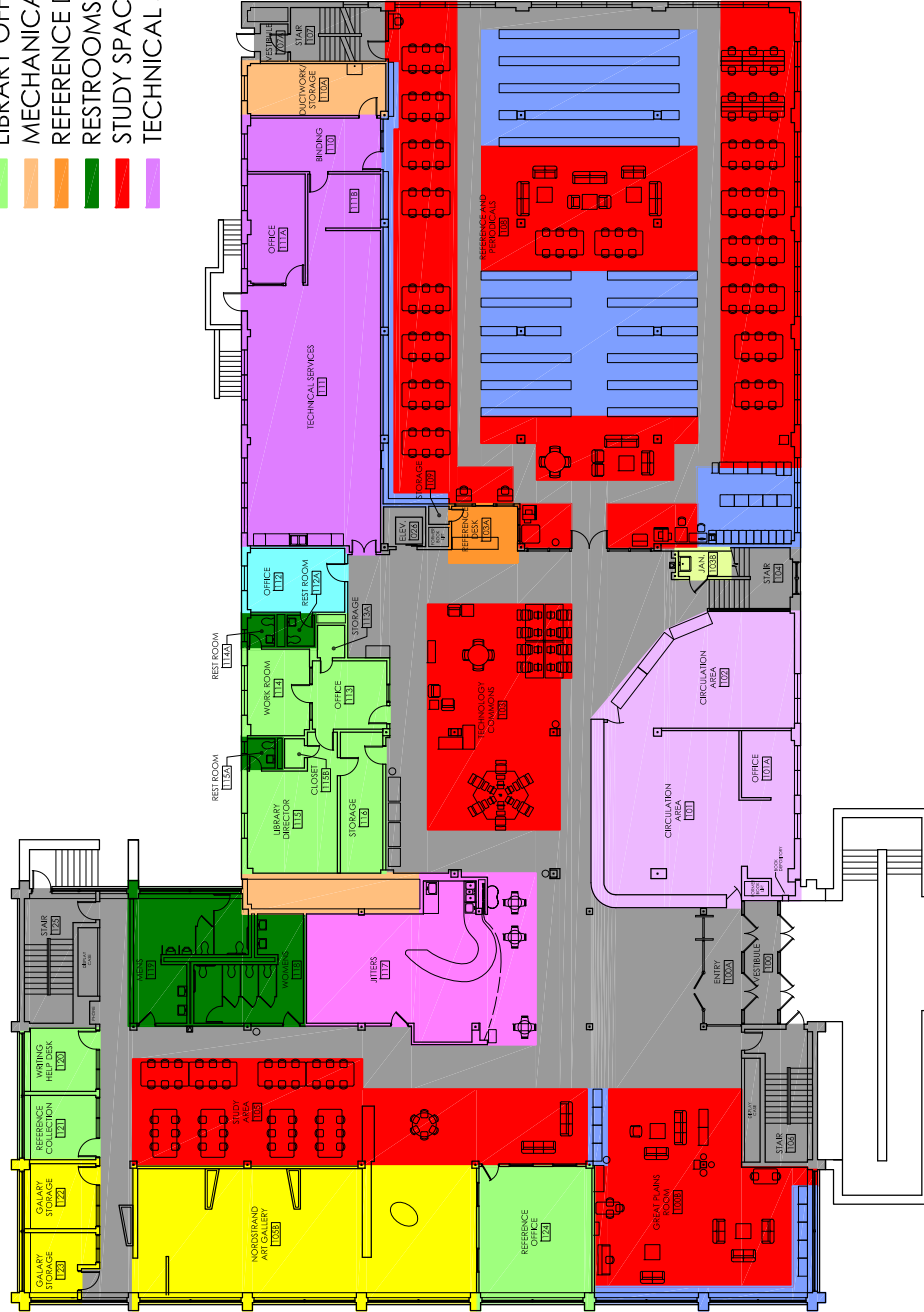
EXISTING FIRST FLOOR PLAN 2
 NORTH SCALE: 1/32" = 1'-0"

- ARCHIVES
- ART GALLERY
- CIRCULATION
- CIRCULATION DESK
- GENERAL STORAGE
- JITTERS COFFEE BAR
- LIBRARY COLLECTIONS
- LIBRARY OFFICES
- MECHANICAL / ELECTRICAL
- REFERENCE DESK
- RESTROOMS
- STUDY SPACE
- TECHNICAL SERVICES

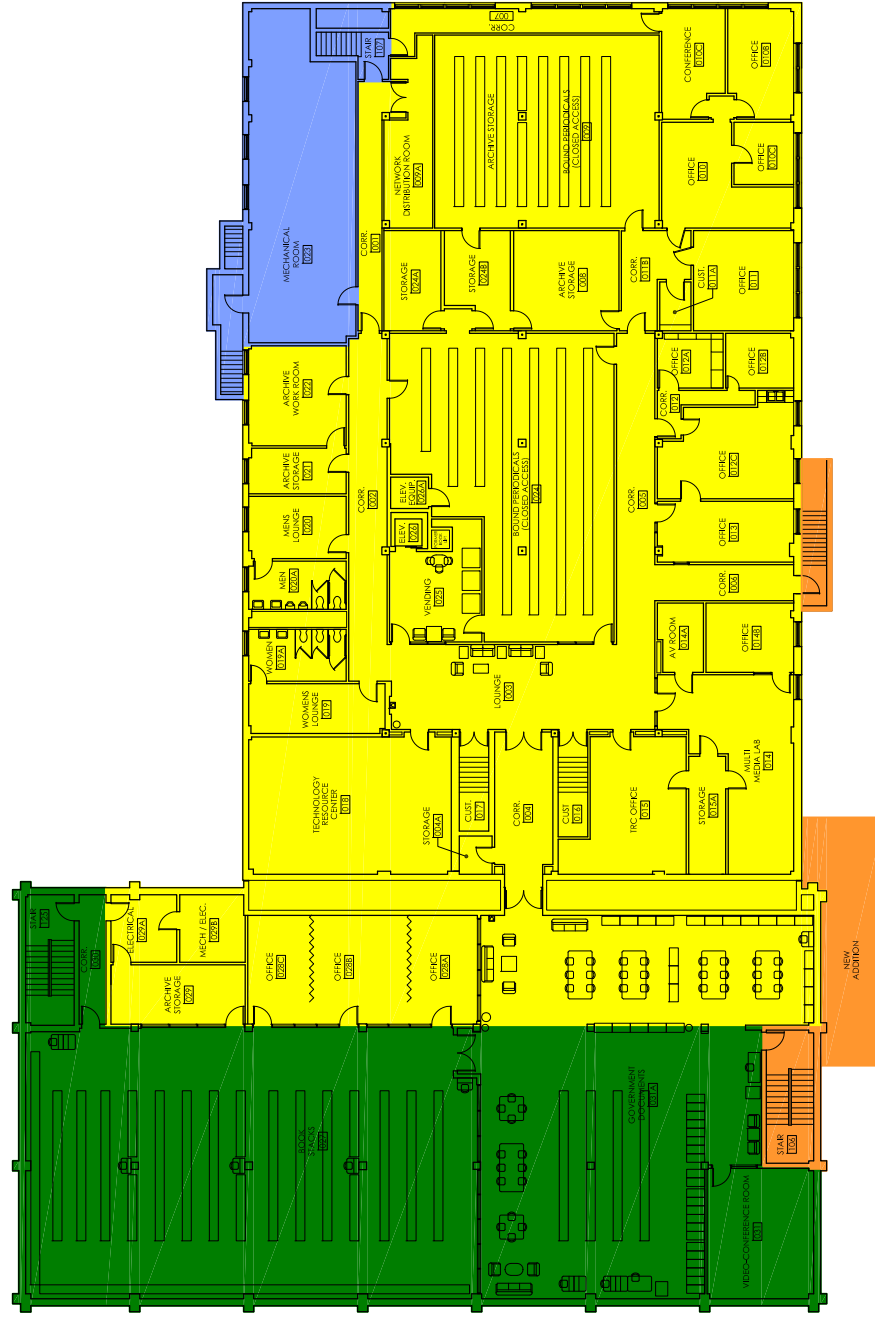
LOWER LEVEL PHASING PLAN 1 7
 NORTH SCALE: 1/32" = 1'-0"

- PHASE I
- PHASE II
- PHASE III
- PHASE IV
- PHASE V
- PHASE VI

- To help mitigate costs associated with the relocation of the existing collections Phase I includes remodeling the existing north lower level to accommodate 19,000 to 20,000 volumes on compact shelving and study space.
- Install the new Mechanical/Electrical building systems equipment and make temporary connections to the existing ductwork to back feed the existing building until replacement work is completed in later phases.
- The Technology Resource Center will have to be relocated prior to the start of Phase I construction.
